HCal Tile Testing Status

April 5th, 2016

Inventory and tile thickness

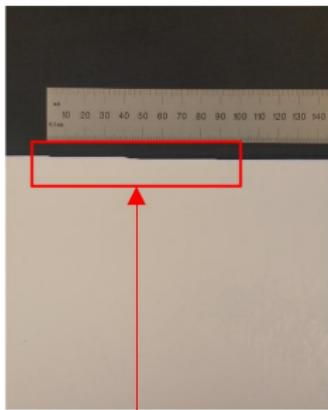
OH-2-6 Visual Inspection

Large steps along the straight edge

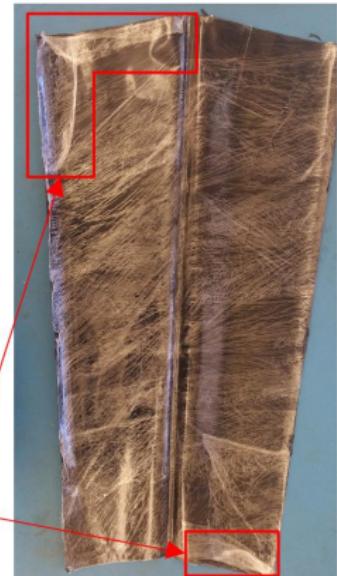
Bunched Wrapping

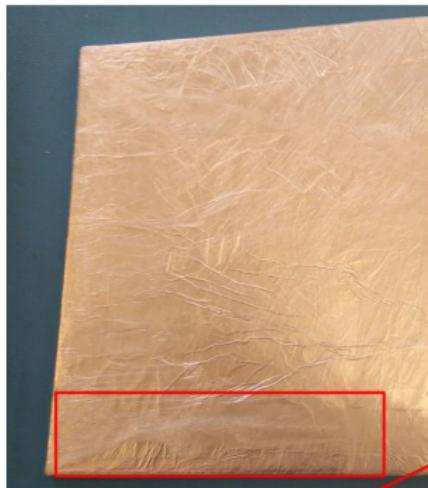
OH-2-47 Notes and Pictures

Wrapping bunched up

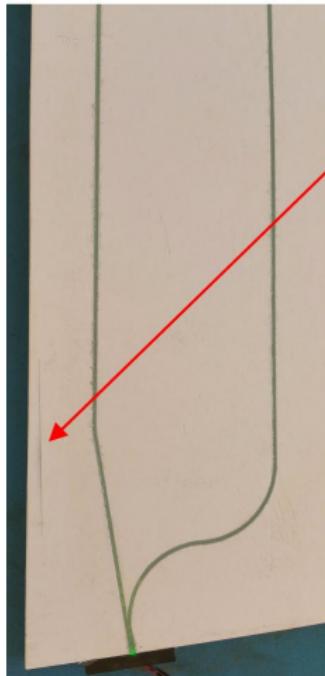
OH 2 47 Notes and Pics

Multiple lines where
the diffusive coating
is notably thinner

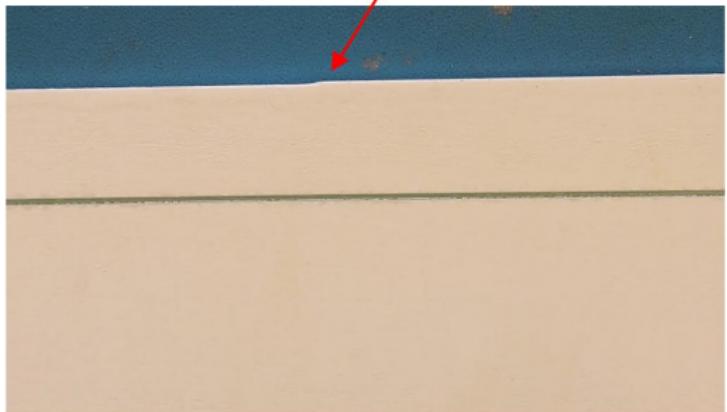
Noticeable rapid change in
thickness along one edge

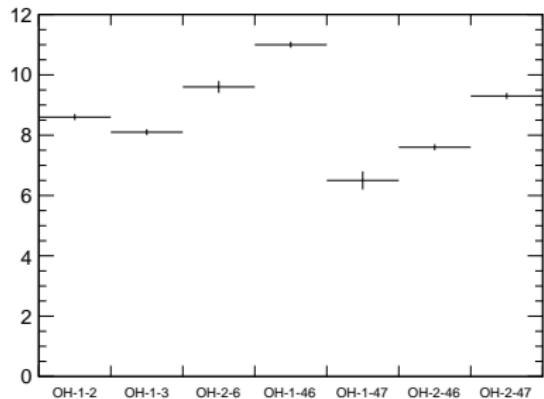
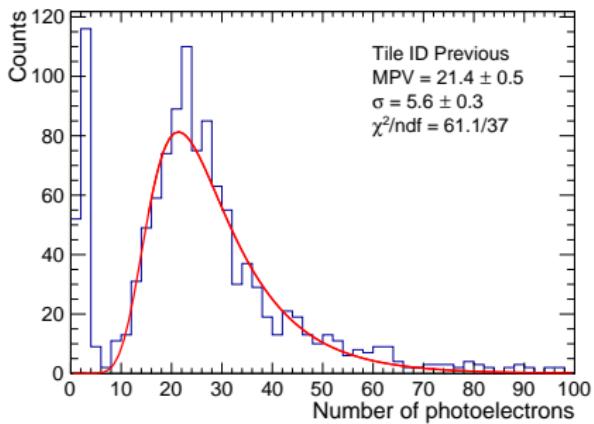
Cosmics Summary

The tiles have statistically significant differences
All are much lower than our previous Outer HCal Tile test (see fig on right)

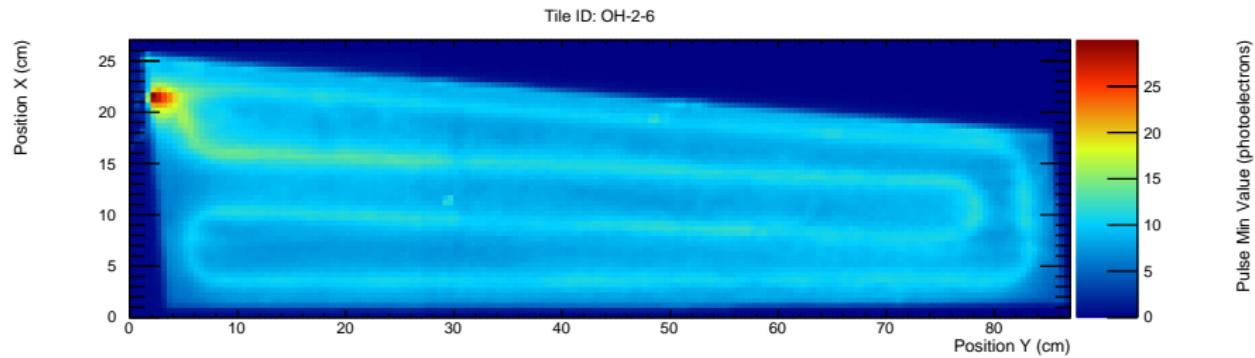
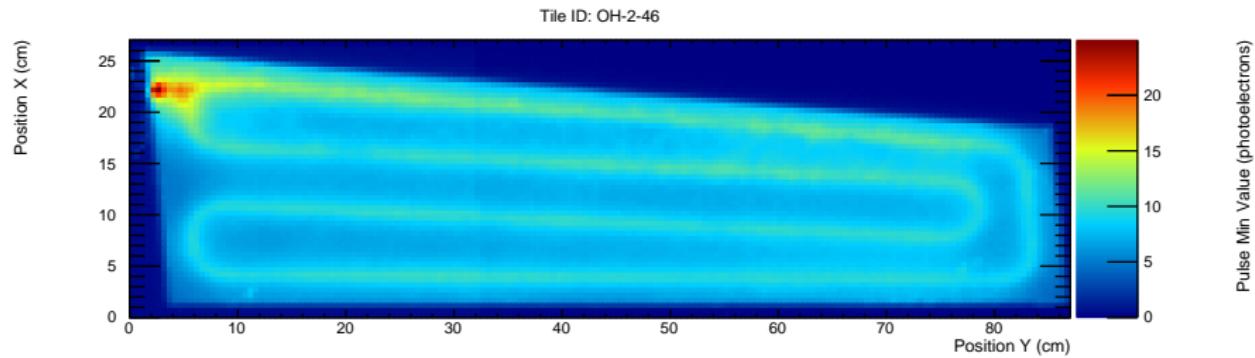
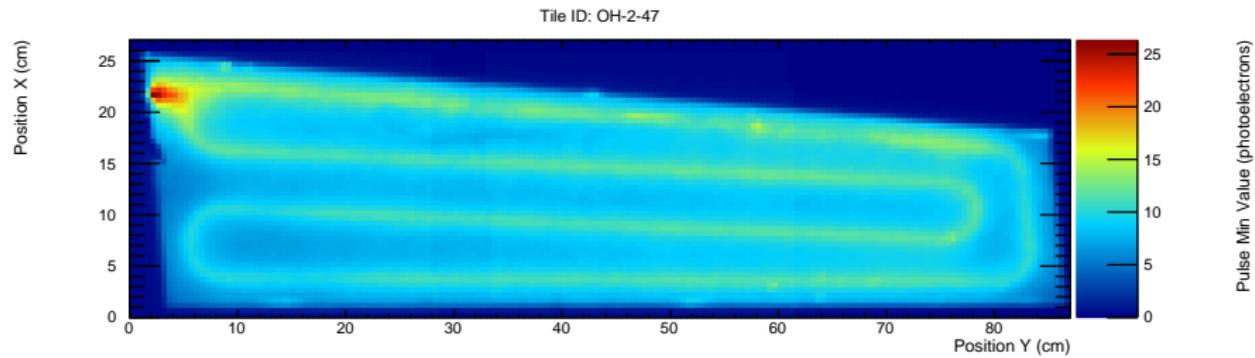
- LED scans show there are no structural issues
- The average LED light output reasonably matches the MPV from the cosmics:

- The lack of structural issues rules that out as an explanation for the lower light yield from cosmics
